ROCK SLOPE STABILIZATION

SOUTHERN EXTENSION OF HALLENBECK ROAD

CITY OF PEEKSKILL - WESTCHESTER COUNTY

OCTOBER, 1975

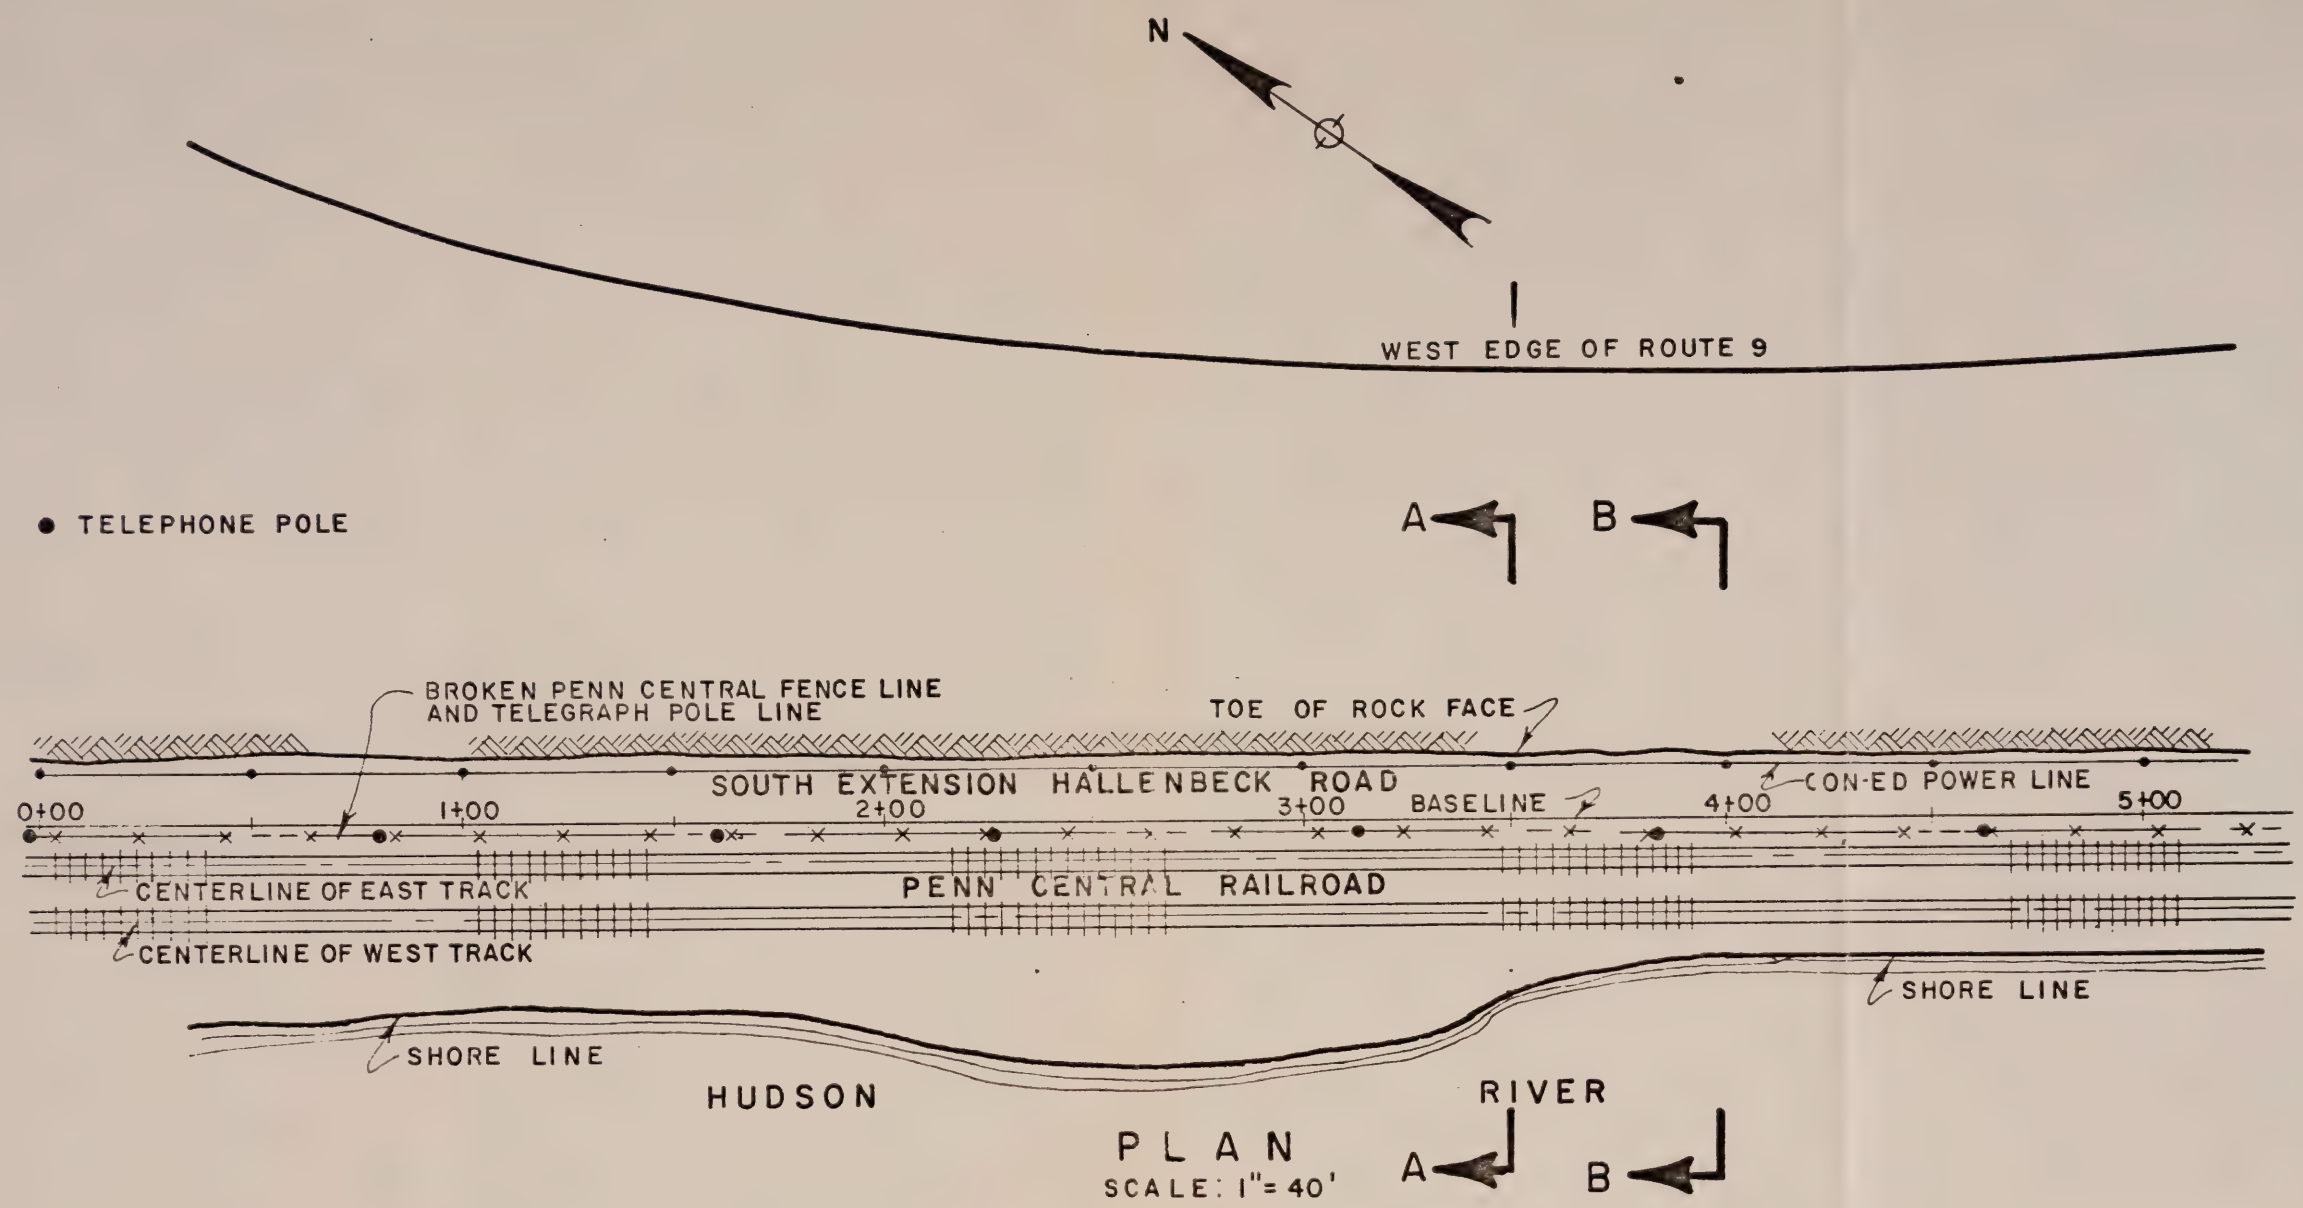
STATE OF NEW YORK  
DEPARTMENT OF TRANSPORTATION  
DIVISION OF DESIGN AND CONSTRUCTION  
ROCK SLOPE STABILIZATION  
SOUTHERN EXTENSION OF HALLENBECK ROAD  
CITY OF PEEKSKILL  
PLAN OF AREA  
DRAWING 1 OF 2

PLAN  
SCALE: 1" = 40'

The slide site is 30 feet in length, however the entire 500 feet of rock slope exhibits structures conducive to imminent rock slope failures. It was determined that an in-depth study should be made of the rock section to determine the best method of correcting the situation. The study was performed during the ensuing months with the assistance of Region 8 Soils' personnel. The study included a survey of the area which is shown by a plan sheet of the site (Drawing No. 1) and representative cross sections (Drawing No. 2).

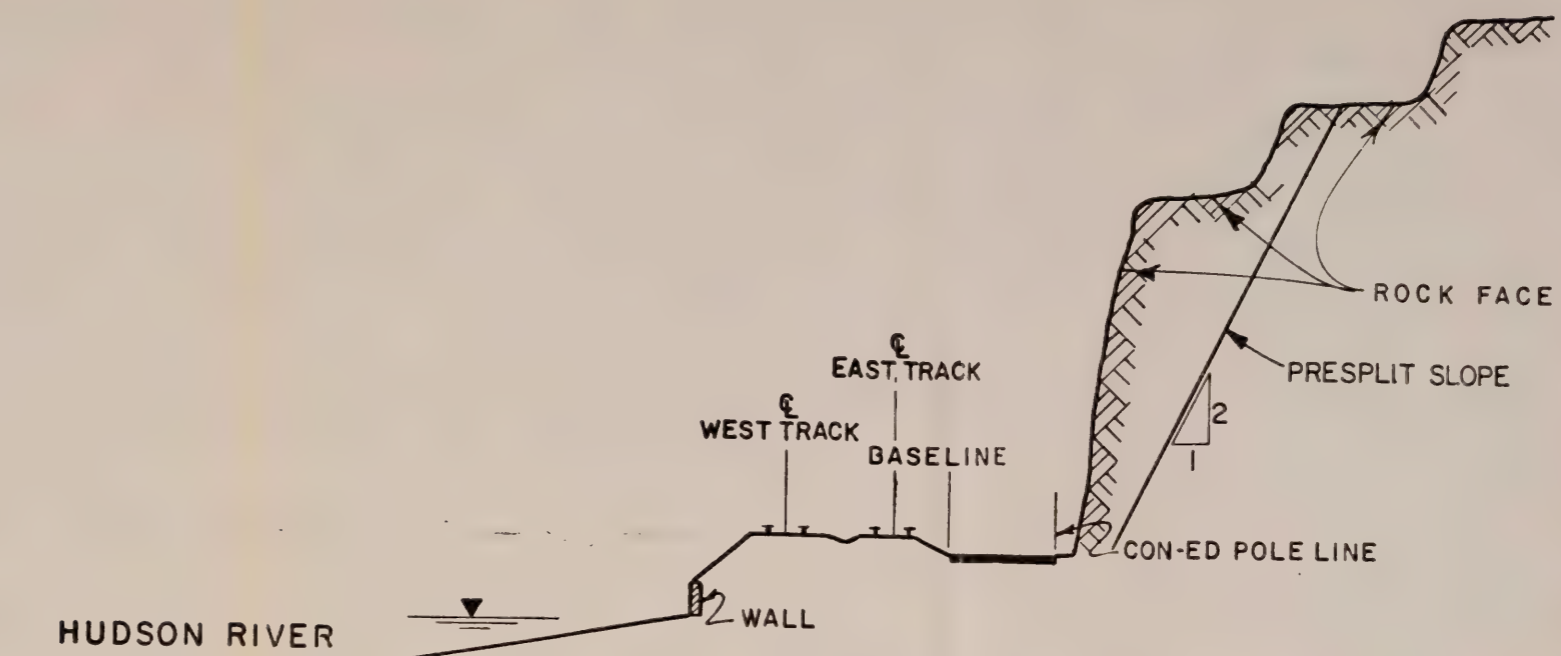
## SECTION B-B

SCALE: 1" = 20'

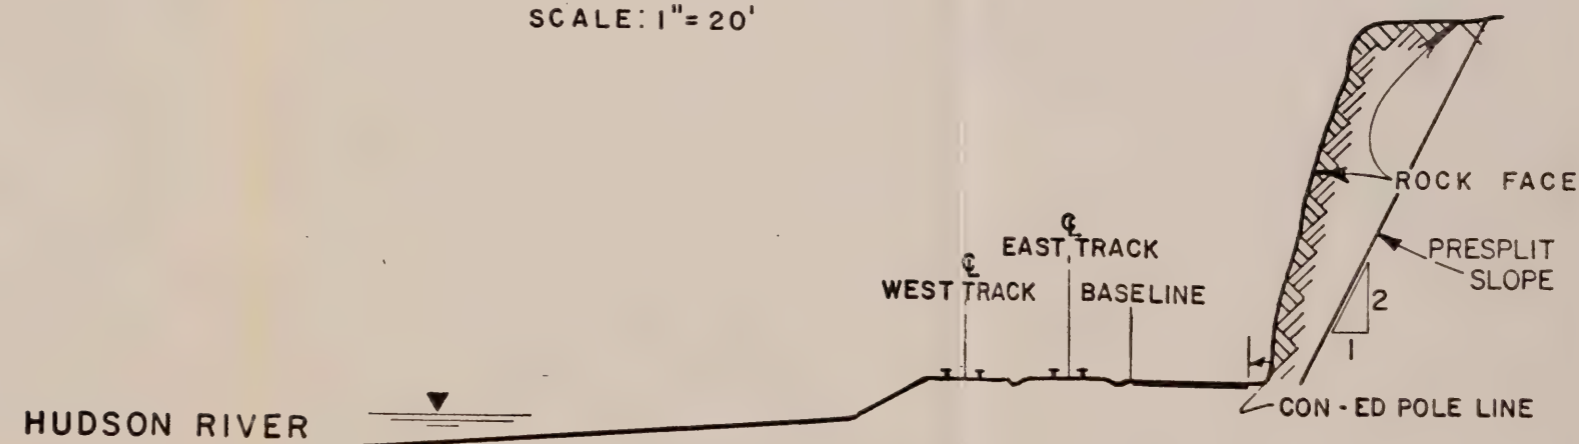
SECTION A-A TYPICAL  
FROM

B STA. 0+00 TO B STA. 3+50

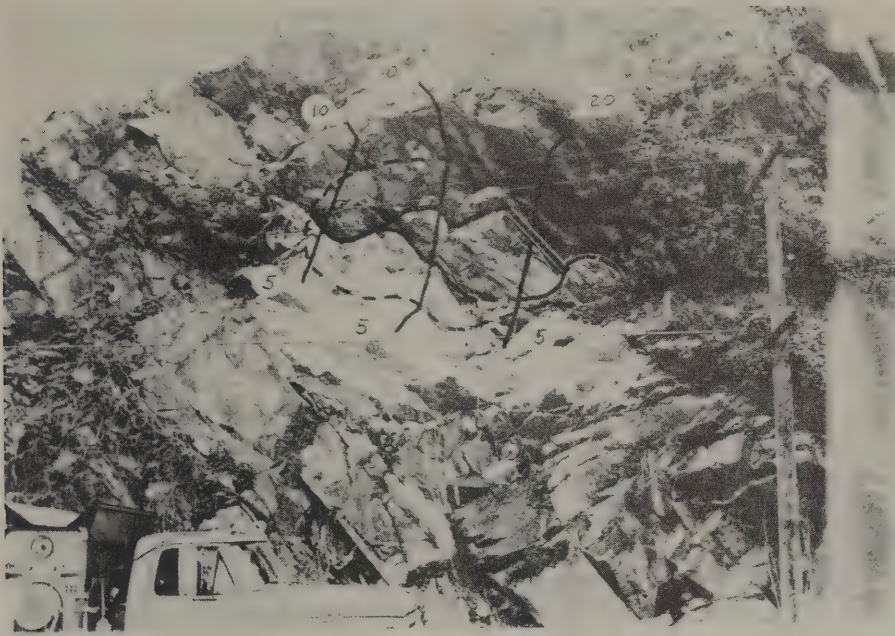
Figure No. 1-Baseline Station 0+60+, left.

- I - Pneumatically projected concrete designated by dashed outline.
- II - Double hingelines to be built up to an 18 inch thickness. The hingelines are designated by two long lines separated by a short dash line.
- III - Bolt locations are designated by hole depth
- IV - Steel straps connecting bolts are designated by solid lines.

Rock Bolts Required

The April 2, 1975 slide area remains unstable. The rock in back of the removed slide material is perched precariously thirty feet up on the rock face. Since it would be extremely dangerous to drill and bolt this rock mass in place without initial support, it is recommended that the slide area be thoroughly scaled by means of high pressure water. The area shall then be supported by several applications of pneumatically projected concrete until the grout has achieved a thickness of approximately 18 inches along the hinge lines (designated by two long and one short dash lines on Figure No. 1, Page No. 10). The area to be stabilized with pneumatically projected concrete is delineated by short dash lines on Figure No. 1. For Pneumatically Projected Concrete Specification see Page No. 22.

The bolt locations and the corresponding drill hole depths are marked on Figures No. 1, 2, 4, 6, 7, 9 and 10 of this report. Please note that in all cases, the length of the rock bolt to be placed shall be six inches shorter than the corresponding drill hole depth. In summation, it will require 306 feet 6 inches of rock bolts to complete stabilization of the rock slope area (33 bolts 4 feet 6 inches in length; ten bolts 9 feet 6 inches in length; three bolts 14 feet 6 inches in length and one bolt 19 feet 6 inches in length).

Steel straps are required at various locations as are indicated on Figures No. 1, 4 and 6 of this report. Straps reduce the number of rock bolts required to stabilize a rock slope of this type. Straps as applied to this area have two distinct advantages: 1) unstable rock masses which cannot be stabilized by rock bolts alone are safely retained, and 2) they enable support of overhanging rock masses which if supported by rock bolts would present an extreme hazard to the workmen during installation. It is estimated that 100 linear feet of steel strapping (five straps 20 feet in length) will be required to complete this work. For Steel Strapping Specification, see Page No. 26.

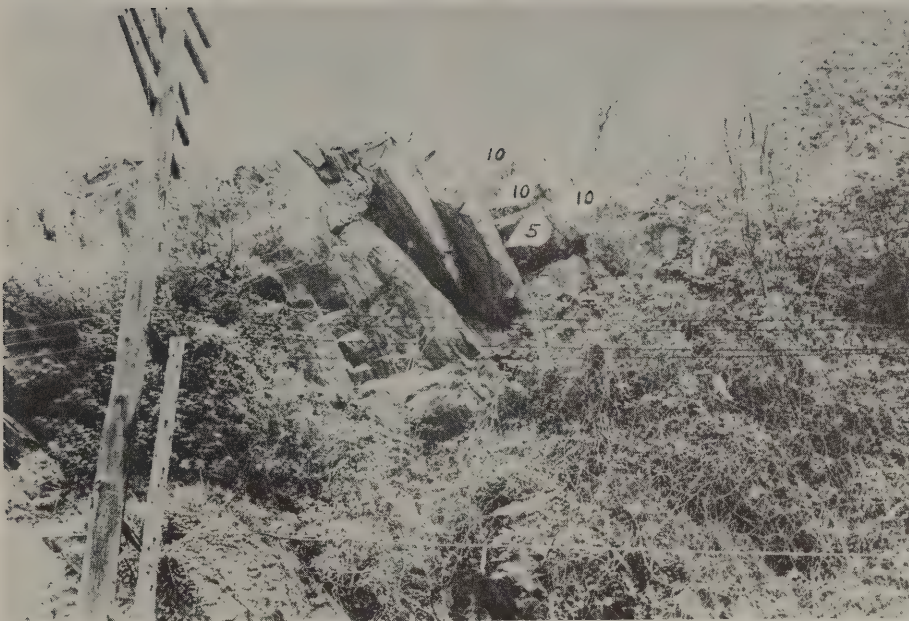
Figure No. 2- Baseline Station 0+92+, left.

Rock Bolts

Construction Sequence

- 1 - 10 foot - upper right
- 2 - 10 foot - upper left.
- 3 - 10 foot - center left.
- 4 - 5 foot - lower left.

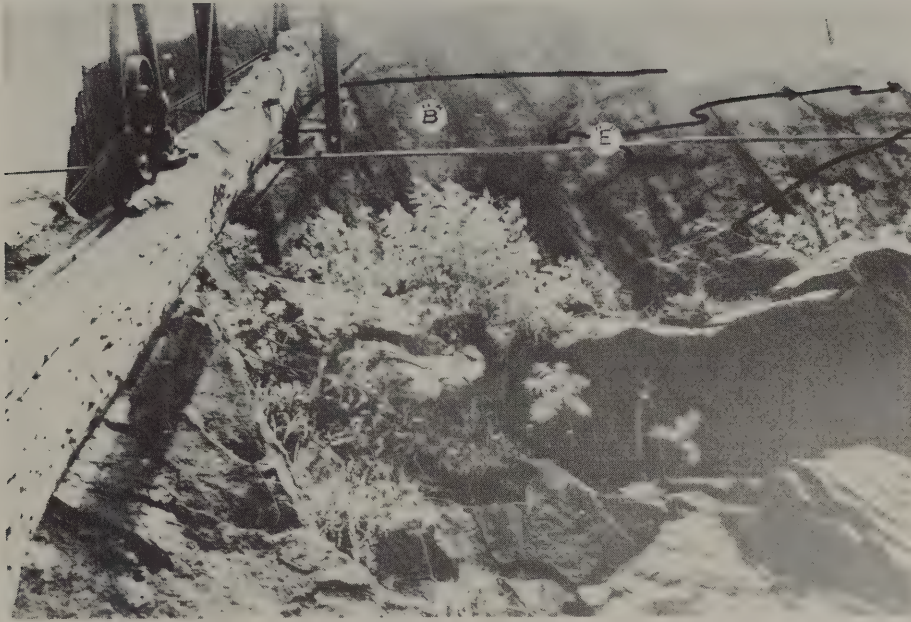
Figure No. 5 - Baseline Station 2+89+ to 3+30+, left.

Overhead view of same location depicted by figure No. 4.  
Note overhang.

Letter "B" indicates upper surface of Joint Set No. 2.

Letter "E" indicates fine tension joints or blasting fractures.

This joint set is marked by its smooth extended surface, typical of cross joints which are tension related. They are formed roughly at right angles to the flow lines. These joints dip to the east away from the roadway which would normally render them of little consequence to the structural stability of the rock face. However, due to the heavy explosive loadings which were apparently utilized in excavating the rock during the construction of the roadway and railroad beds, the rock at the toe of the slope was badly fractured and ultimately removed during the excavation operation (See Figure No. 9, Page No. 17). This resulted in the creation of a hanging wall effect which allows even the most casual observer to wonder what holds the overhanging mass of rock in place. A similar situation occurs in one location illustrated by two different views, Figures No. 4 and 5, Pages No. 13 and 14. Here the hanging wall effect was created when the blast holes were stemmed (filled with nonexplosive material, probably sand) to a depth of ten to twelve feet below the rock surface. The explosive gases created during the blast detonation escaped through this joint (the upper surface of which remains) thereby reducing the pressure and preventing the fragmentation of the hanging rock area. Joint Set No. 2 is denoted by the letter "B" in the figures mentioned above.

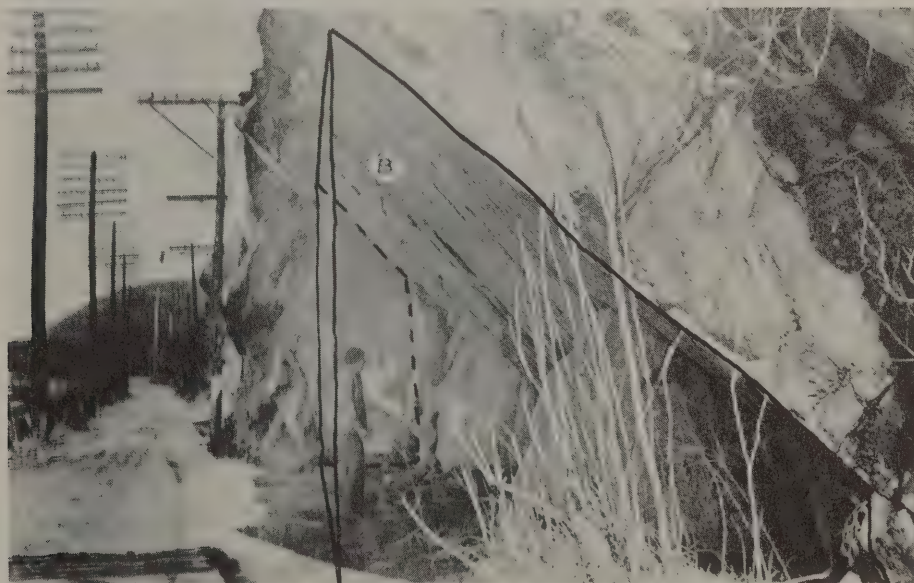
Figure No. 8 - Baseline Station 3+60+, left.  
Area outlined in black shall be formed and filled in four  
stages with Cyclopean Concrete .  
Letter "B" designates upper surface of Joint Set No. 2

The stabilization of the hanging wall rock mass depicted in Figure No. 8, Page No. 16 of this report can be supported by a reinforced concrete wall or by reinforced concrete columns. Due to the high cost of structural concrete and the hazard involved in working in this area, it is recommended that forms be constructed along the three walls outlined in black on the photograph and the entire void filled with concrete. It is estimated that 150 cubic yards of concrete will be required to perform this operation. The quantity of concrete necessary could be reduced by 50 percent by utilizing the large pieces of rock removed during the scaling operations and from the stockpile of slide material adjacent to the problem area. This rock is of excellent quality and would not reduce the strength of the supporting concrete. Concrete containing large boulders of this type is known commonly as Cyclopean Concrete.

The dirt area under this overhang should be removed (preferably by high pressure water) to expose the bedrock on which to support the concrete pour.

It is further recommended that the pour be conducted in four stages with the first stage constructed to a height of three feet above the present roadway grade, the second stage four feet in height, the third stage five feet in height and the fourth final stage capping the support with a six foot high pour in the top wedge shaped area. No rock larger than six inches in diameter should be utilized in the final pour stage.

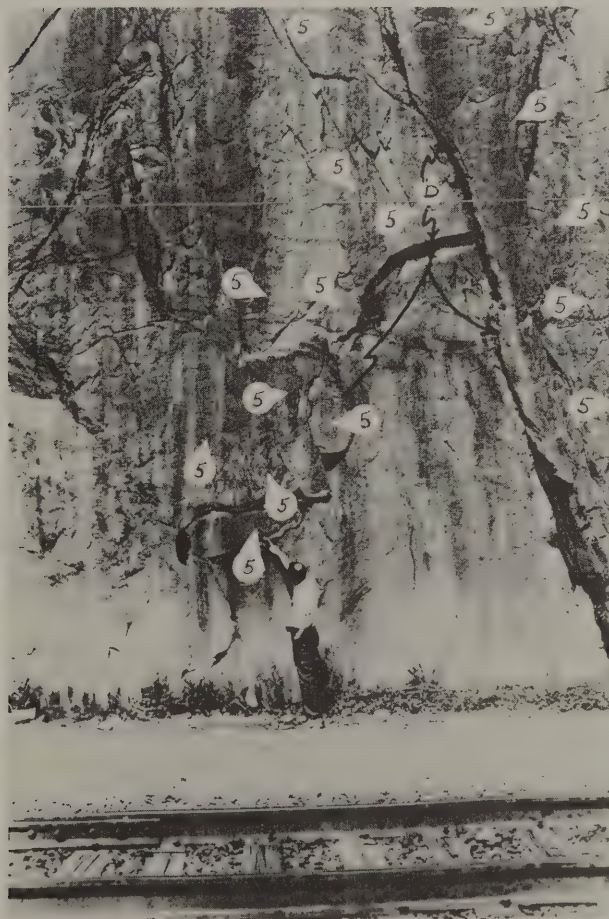
Figure No. 10 - Baseline Station 4+93+, left.  
Rock Bolts - 15 @ 4'-6" = 67'-6" Total  
Install top bolts first and continue toward bottom.  
Letter "D" designates Joint Set No. 4

Joint Set No. 4 is located at the south end of the rock slope just north of the major boundary fault between the Reservoir granite and the Manhattan schist. These joints are known as feather joints which are tension joints whose origin is directly related to faulting. The rock which exists above the location where the joint intersects the rock face presents a very real and impending rockfall hazard. Should the rock in front of this joint surface become dislodged it would cover the road, both tracks and undoubtedly some rock would even reach the river. This area is not located in the original construction blast area. It is a natural unstable rock structure created by the local faulting.
